**INVESTIGATION OF AN ALUMINUM ROLLING HELIX CRASH
ENERGY ABSORBER**

ARA, Inc.
2017 W. Garvey Avenue
West Covina, Calif. 91790

May 1977

Final Report for Period February 1975 - December 1975

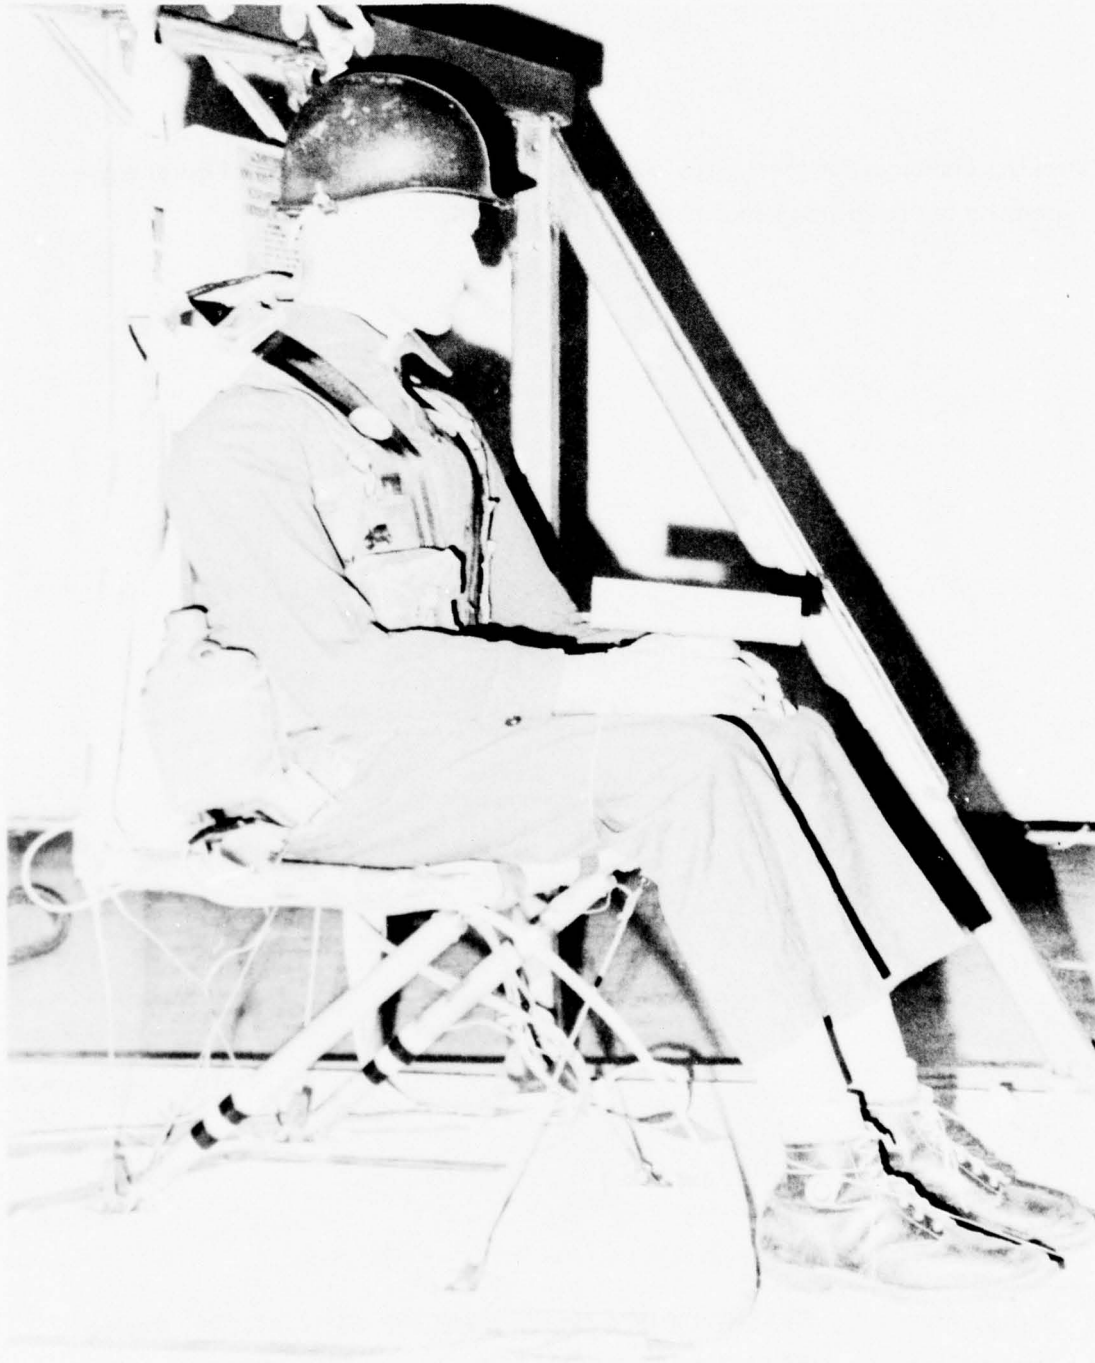
Figure 4. Typical Troop Seat Utilizing Energy-Absorbing Legs.

stroking distances for the energy absorber. A typical application of an energy-absorbing leg for a troop seat is shown in Figure 4.³
